Manhole Inspection Summary

Manhole # S19C1_009MH

Insp Date: **11/17/08 10:50 AM**

Location Address: **1952 sponson st**

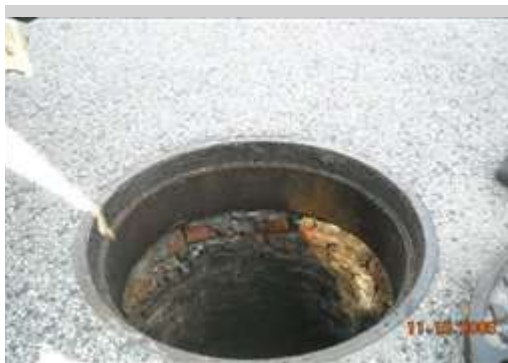
MISC.

☐ Prev. Rehab Weather: **Dry** Subject To Ponding: **Sheeting**

INFLOW EVIDENCE FROM SHEETING

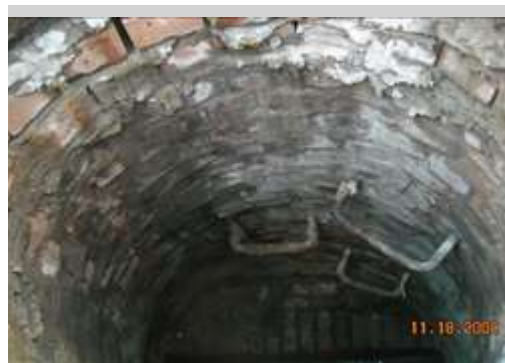
Defect 3

Steps Count: **3** Missing: **1** ☒ **Corroded**

CORRODED & MISSING STEPS

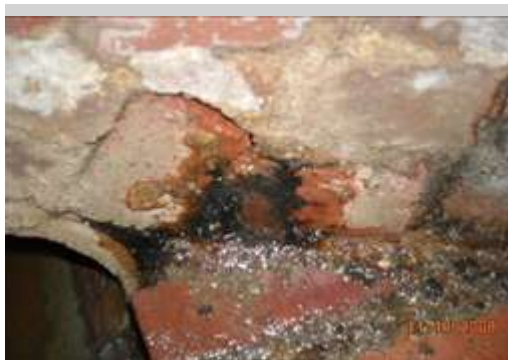
Defect 2

Infiltration: ☐ None ☐ Joint ☐ Cracks ☐ Mortar ☐ Roots ☒ **Wall**

INFILTRATION @ BARREL WALL

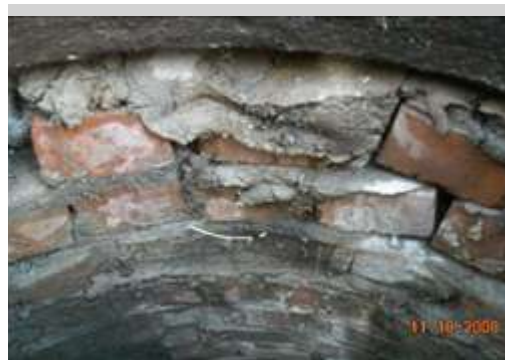
Defect 1

Infiltration: ☐ None ☒ **Joint** ☐ Cracks ☐ Mortar ☐ Roots ☐ Wall

INFILTRATION @ CHIMNEY/FRAME JOINT

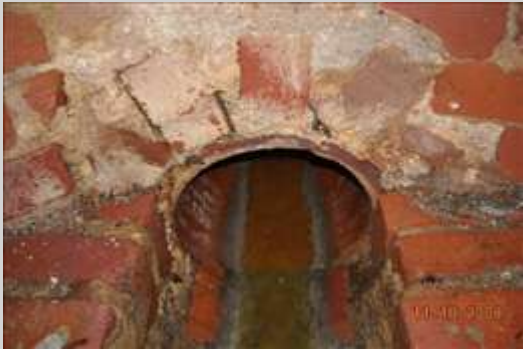
12 O'Clock Outflow

8 in. Circular Gravity Sewer
Pipe Out @ 12 O'Clock

Pipe Height: **8.4** (in.) Rod and Bar (Angled)
Pipe Material: **Clay** ☐ Pipe Lined
Invert Depth: **8.00** (ft.) Flow Characteristics: **Slow**
Deposits: ☒ None ☐ Mud ☐ Sludge ☐ Debris ☐ Grease
Silt Depth: **0** (in.) Deposits Extent:
Infiltration: **None** Pipe Seal Cond: **Cracked**
